Belize Aircraft Accident and Incident Investigation Unit

A-003-05-1990

V3-HDY

CESSNA 206

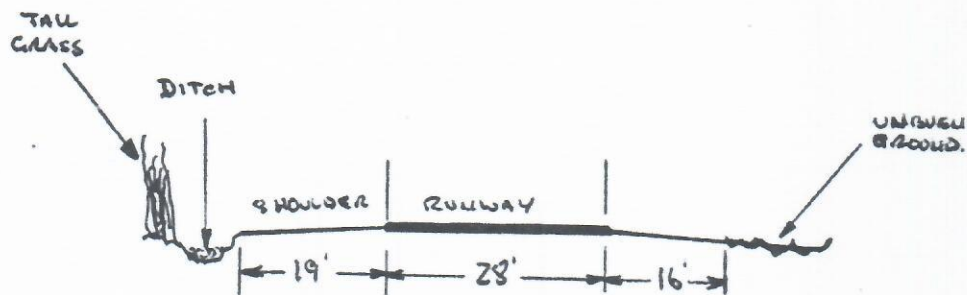
The runway orientated 09/27 is 2200' long and 28ft wide. The cleared strip should go to 100' on either side of the runway centre-line cleared and graded, to be capable of supporting the weight of aircraft using the aerodrome to permit immediate recovery of aircraft inadvertently leaving the runway as is the subject of this report.

The Pelican Airstrip extends to 19 and 16 ft. on either side of the runway centreline, and then dips down dangerously beyond these measurements. A cross section profile is as shown:

- 4.1 The Pelican Airstrip be widened to 100' with a 40' runway and the sides and approaches be cleared of any obstructions.
- 4.2 Company Policy be changed to reflect a higher number of hours on type before new recruits are released to captainship.
