## Belize Department of Civil Aviation

**Report No.:** A-001-11-2017  
**Name:** Accident Investigation Final Report  
**Registration:** V3-HGX.

**CESSNA 208B GRAND CARAVAN  
17 NOVEMBER 2017  
PLACENCIA AIRPORT, PLACENCIA VILLAGE  
STANN CREEK DISTRICT, BELIZE C.A.**

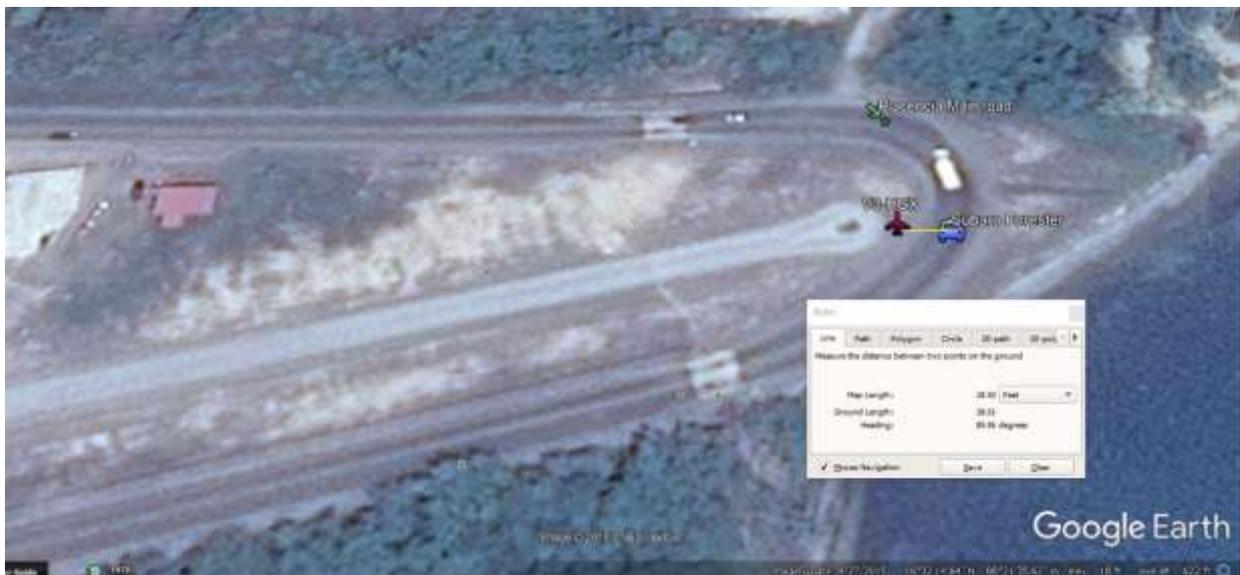
**FIGURE 2: Google Earth Map 2 – V3-HGX/ SUV IMPACT AREA**

**1.00.2 PLACE OF IMPACT:** The aircraft made impact with the Caribbean Sea approximately 200-300 feet to the northeast from the end of runway 07 at Placencia (figure 1 Google Earth Map 1). The pilot ditched the aircraft after the right main wheel made contact with the right side of a vehicle (see figure 3) at approximately 28 feet east from the end of Runway 07. The aircraft was airborne at an altitude of approximately 5.5 feet above ground level when it made contact with the top vehicle. (See figures 1, 2 and 3 below).

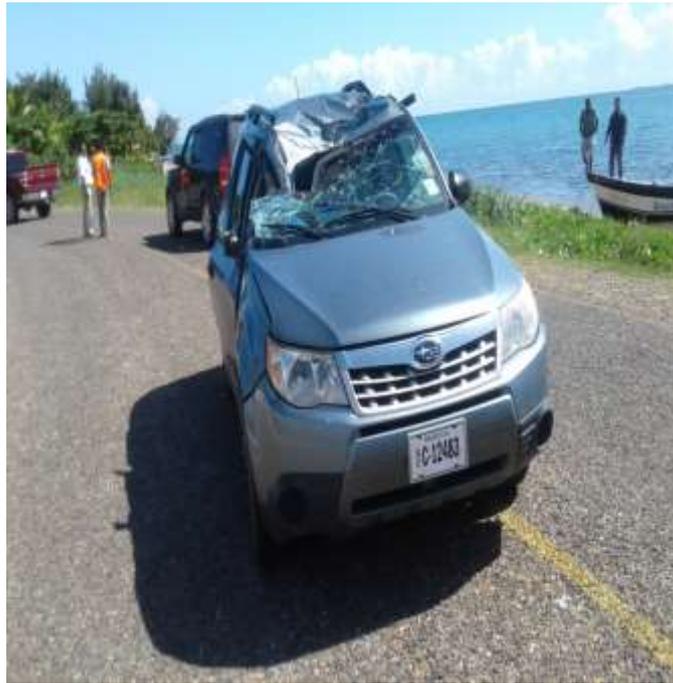
**FIGURE 3: Vehicle Impact whilst on Placencia Road**

**1.03. Other Damages:** The only other damage caused during this accident was limited to the top of the vehicle which was being driven along the Placencia road. (See figure 3 for Subaru damage).

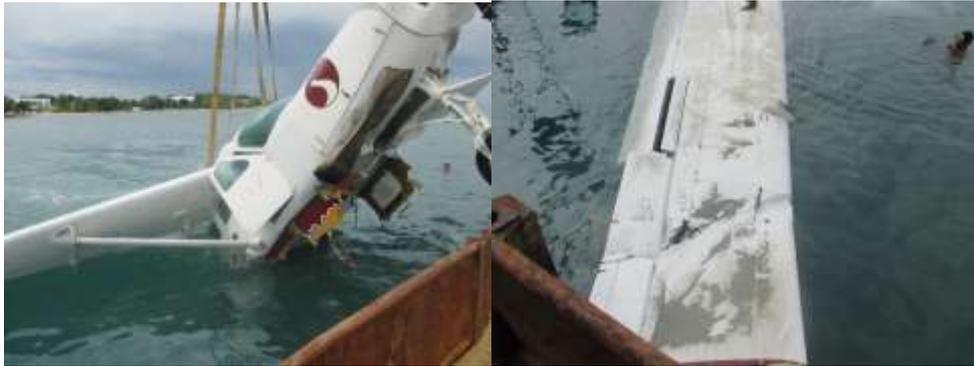
**FIGURE 4: AIRCRAFT DAMAGE**

- a) Cargo pod was completely torn up to the second compartment.
- b) All propeller blades had structural damage.
- c) Engine exhaust was completely compressed due to the impact.
- d) STBD wing and aileron were broken at aileron center station.
- e) Landing gear fairing.
- f) Water damage to the entire structure. (See Figure 4 below)

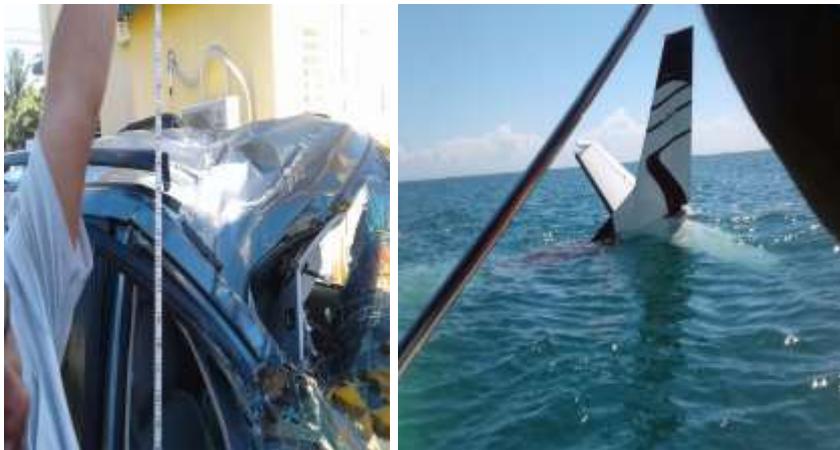
**Damages to Aircraft and vehicle** The windshield and roof of the vehicle were extensively damaged as a result of the impact of the aircraft as shown below.

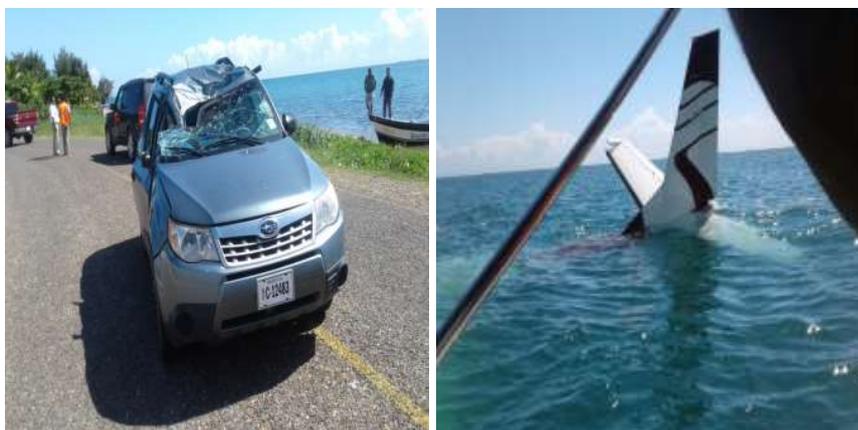
1. The aircraft was extensively damaged due to the impact from crash landing in the Caribbean Sea as shown in the picture below.
2. The aircraft was removed from the sea and the engine was removed from the airframe for further investigation.
