# **Belize Aircraft Accident and Incident Investigation Unit**

SI-001-02-90

**Final Report**

**B737 AND BN2A**

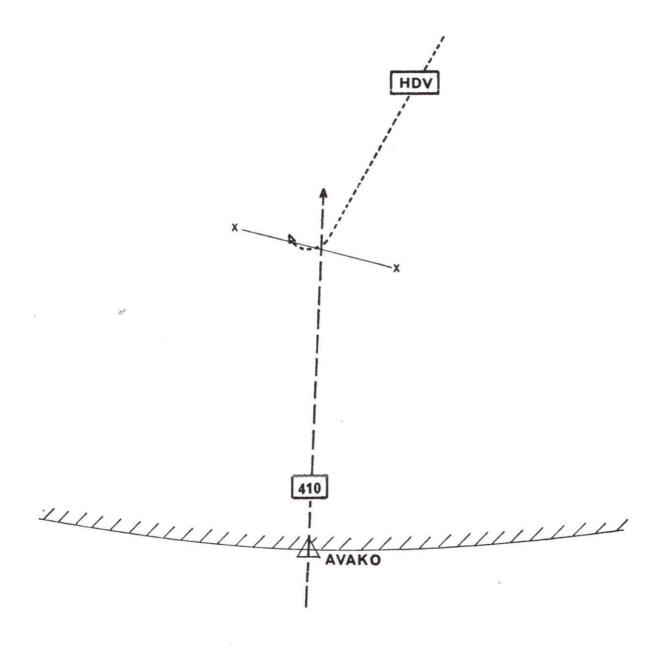
APPENDIX A

2.4 The relative flight paths of the two aircraft immediately before and during the Airmiss are illustrated in Appendix A.
