## Belize Department of Civil Aviation

**Report No.:** A-001-11-2017  
**Name:** Accident Investigation Final Report  
**Registration:** V3-HGX.

**CESSNA 208B GRAND CARAVAN  
17 NOVEMBER 2017  
PLACENCIA AIRPORT, PLACENCIA VILLAGE  
STANN CREEK DISTRICT, BELIZE C.A.**

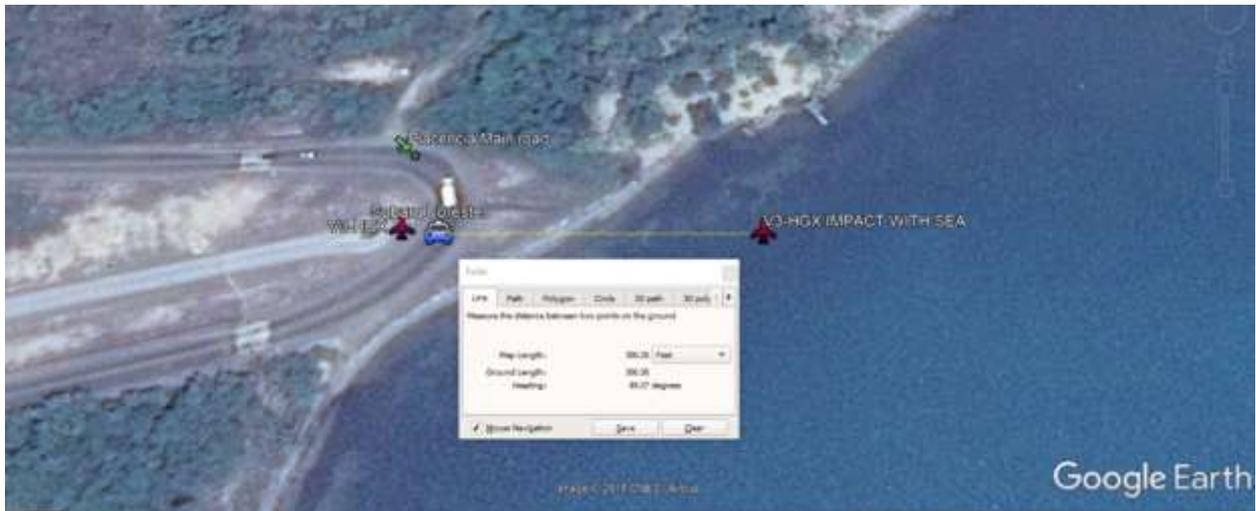
**FIGURE 1: Google Earth Map 1- Impact Point & Final Resting Position**

**1.00.2 PLACE OF IMPACT:** The aircraft made impact with the Caribbean Sea approximately 200-300 feet to the northeast from the end of runway 07 at Placencia (figure 1 Google Earth Map 1). The pilot ditched the aircraft after the right main wheel made contact with the right side of a vehicle (see figure 3) at approximately 28 feet east from the end of Runway 07. The aircraft was airborne at an altitude of approximately 5.5 feet above ground level when it made contact with the top vehicle. (See figures 1, 2 and 3 below).

The emergency landing area was in the Caribbean Sea at a distance of 200-300 feet to the northeast of the main shoreline located directly in front of the runway 07 at Placencia Airport. (See Figure 1 – Google Earth Map 1). The depth of water did not exceed 25 feet of salt water.

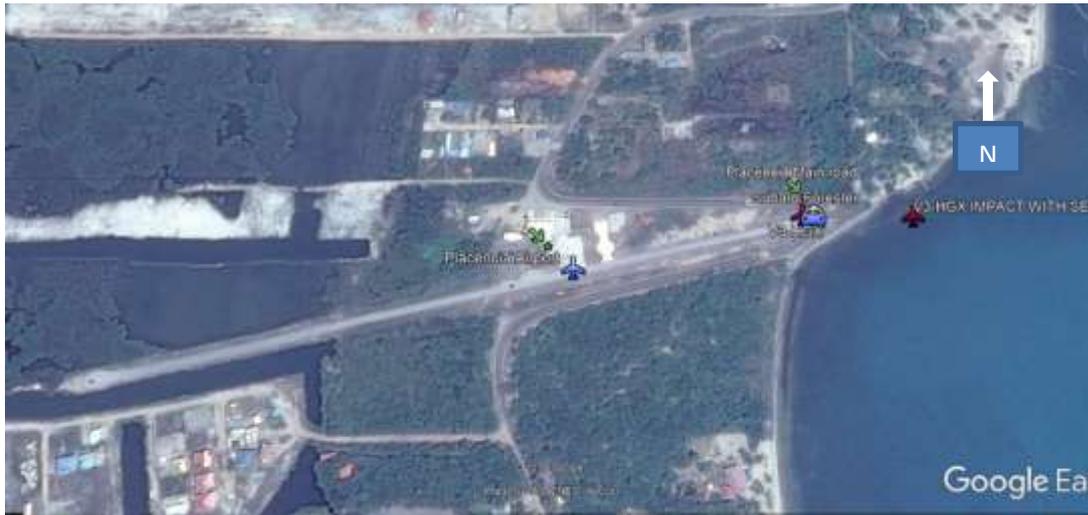
**FIGURE 5:** Google Earth Map 1- Map of the accident site

The airport was built around the main public access road which joins Placencia to the southern highway. The location of the aerodrome presents an inherent hazard of having motor vehicles drivers, who are not aware of the danger of aircraft taking off/landing, driving in front of the approach or landing path of aircraft and causing a aircraft and vehicle collision. The Belize Airport Authority, prior to this accident, had installed barriers and signage on the main road to warn/prevent/stop vehicles that were approaching the end of runway 07 and were not cognizant of the fact that aircraft are operated at a very low altitude when crossing over this portion of the road (See figure 5 map below).
